SUSTAINABLE MANAGEMENT OF THE WOMANGUE WATERSHED IN LIMBE, CAMEROON: REDUCING THE RISK OF FLOODING AND LANDSLIDES

INSTALLATION OF DRAINAGE TRENCHES SYSTEM IN AN URBANIZED AREA UPSTREAM OF THE WOMANGUE RIVER WATERSHED

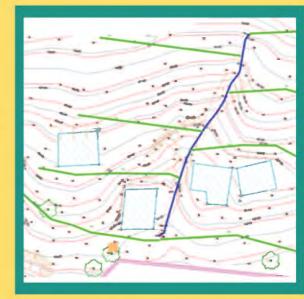
Sigth of Limbé draining trenches network:

- Navy blue, the opened main drain
- Green, draining trenches
- Light blue, people's accomodation

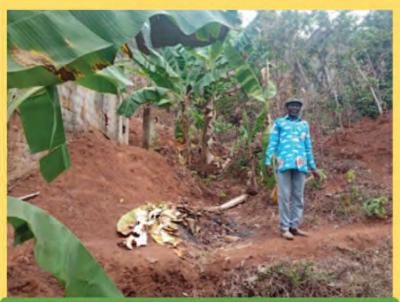
View of the natural talweg before construction

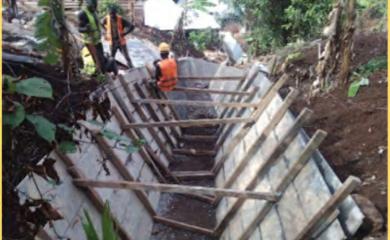
Formwork and reinforced concrete pouring by section

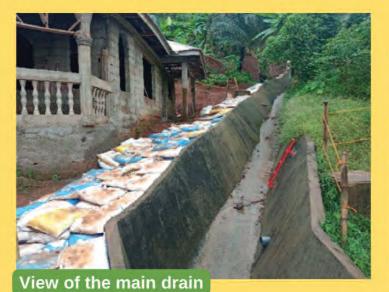
View of the service ladder and footbridge downstream of the main drain

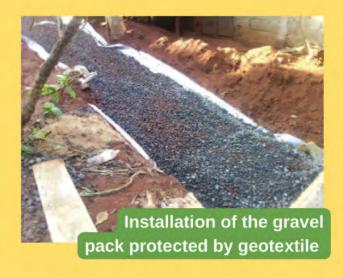
Rainwater is collected by the in-ground drain and ispoured in the main drain

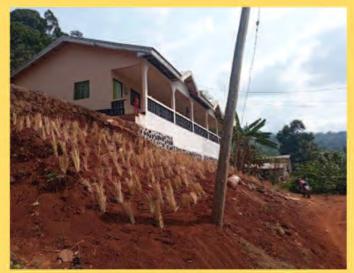
View of protective plantings downstream of the terrace

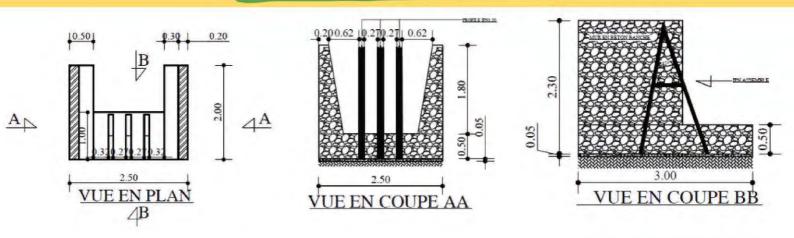
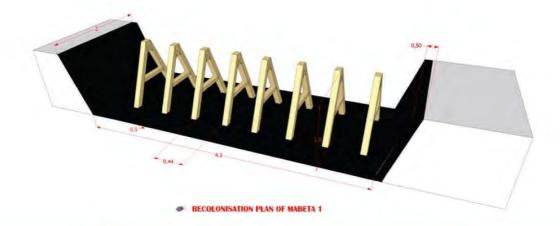
SKETCHES

Metal connections consisting of 120 mm wide IPNs welded in a triangular shape and embedded in the concrete mass. The base of the joints is adjusted to the width of the river bed. The two bars considered as the sides of the triangle reinforce the stability of the unit (triangular), while the bar considered as the base of the triangle reinforces the strength of the trap. The number of units depends on the width of the watercourse. The interval between two joints is set at around 50 cm, based on testimonials from inhabitants. These joints are protected by an anti-corrosive coating.

Two side blocks that extend the base to the upper limits of the river banks. They are also made of simple, water-repellent concrete, reinforced with rubble stone.

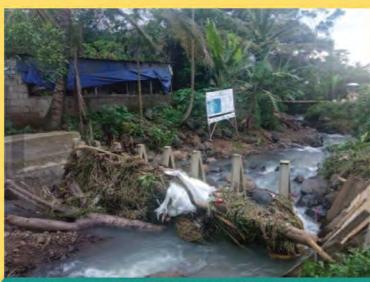
Upstream and downstream views of the logjam trap at site 3 after a heavy rainfall

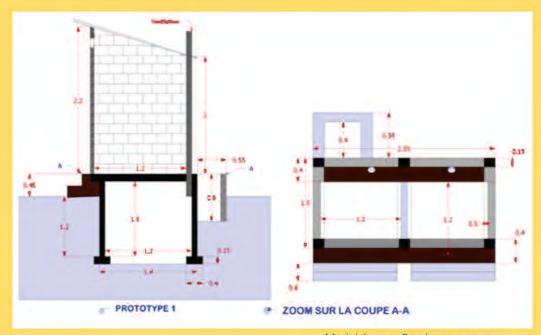
Model 1: non-flood-prone area

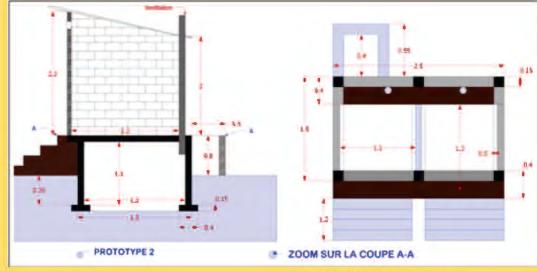
Model 2 : flood-prone area

This model comprises the same elements as Model 1, with the difference that the pits are made up of two 1,000-liter plastic cubitainers. The superstructure enclosing the cubitainers is raised above the natural terrain to remain out of the water during flood episodes, which may require the installation of several steps to access the cabins.

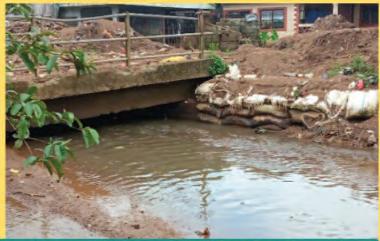
View of impacted earthbags after heavy rains, without being washed away by the flood.

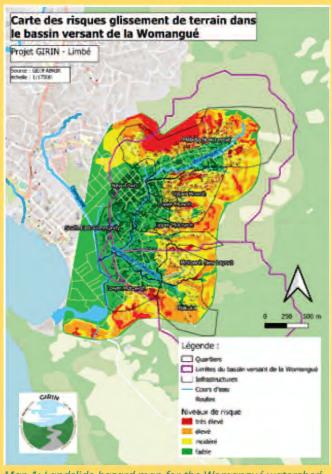
Map 1: Landslide hazard map for the Womangué watershed.

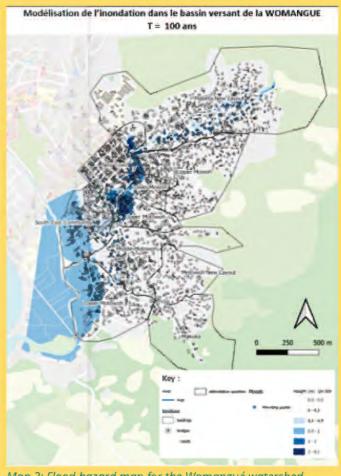
Map 2: Flood hazard map for the Womangué watershed.

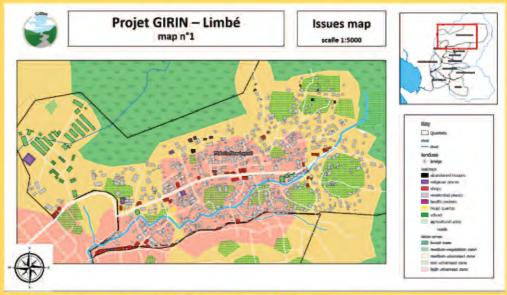
Map 3: Map of issues in the Mabéta district, located in landslide-prane areas

The issues at stake concern the economic assets and social facilities associated with the buildings and surface areas. The maps also distinguish between non-urbanized areas (agricultural, natural), densely urbanized areas and moderately urbanized areas.

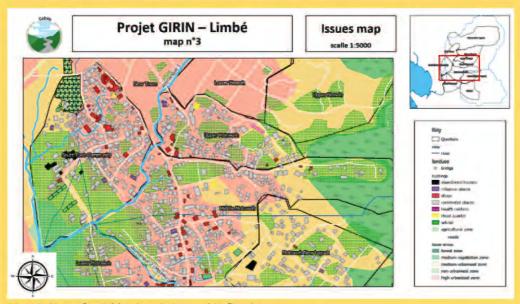
Map 4: Map of neighborhoods located in flood-prone areas

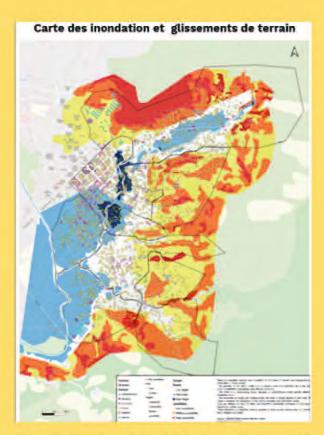
Map 5: Flood and landslide hazard map with watershed-wide issues

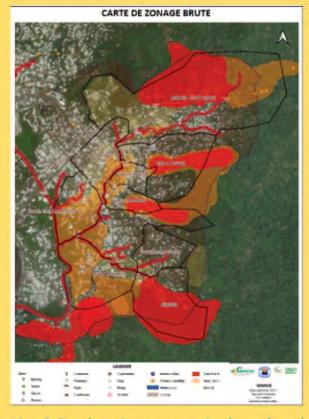
Map 6: Rough zoning map crossing hazards and issues at the watershed scale

The raw zoning established will form the basis for the consultations to be organized during phase 2 with stakeholders, in particular the population of the project area.

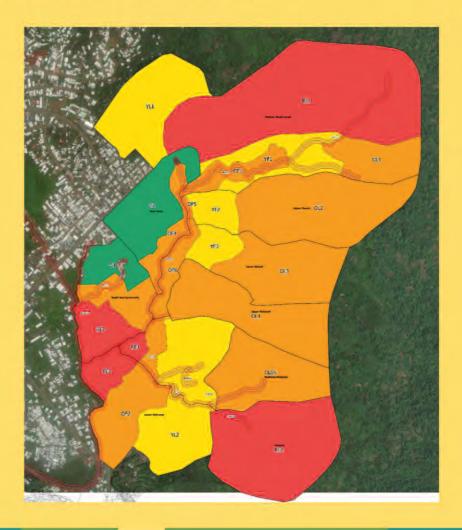
Example of regulatory zoning for each neighborhood

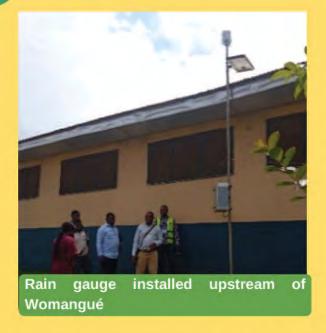
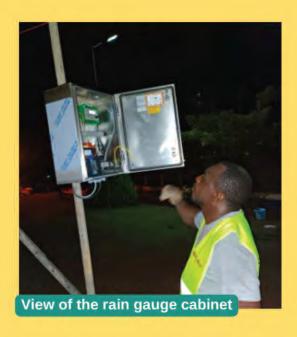
Installation of a pressure transducer central unit and view of the connection cable to the submerged module

View of a water level station and the cable connecting the submerged pressure sensor module to the central unit installed on the bank.

- Automatic rain gauges are mounted on a metal mast, with the rain gauge at
 the top connected by cable to the data acquisition unit, which is protected by a
 box that records and stores the data. The data is transferred via the data
 acquisition unit's modem. The device is powered by an autonomous system
 consisting of a solar panel and a battery that takes over in the event of a solar
 panel malfunction.
- The pressure sensors consist of a submerged module connected by a cable of variable length (between 15 and 20 meters) to a central unit located on the bank. They automatically measure water level data. The device is powered by locally available, replaceable batteries.
- Limnimetric scales enable manual measurement of water levels. These are plates graduated from 0 to 1 meters, superimposed and fixed to bridge piers by means of metal bars.

The pressure transducer and water level gauge are installed together to form a hydrological station. The control software is OTT Water Logger. Data from a hydrological station can be used to:

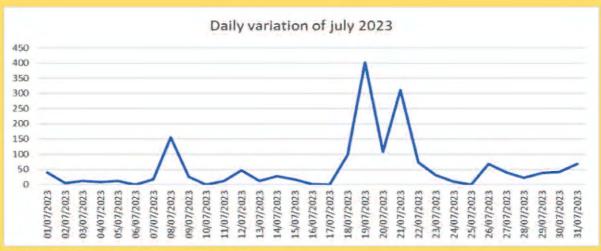
Daily rainfall variation in July 2023 (mm)

Prior to the installation of rain gauges in the Womangue watershed, rainfall data for hydrological and hydraulic studies in Limbé were virtually non-existent. Thanks to the equipment installed, Limbé now has a reliable rainfall and hydrometric database. The stations have provided invaluable information on the devastating rainfall in Limbé in July and August 2023. As a result, the extent of the flooding caused by these rains was better explained to the Limbé authorities and the local population.

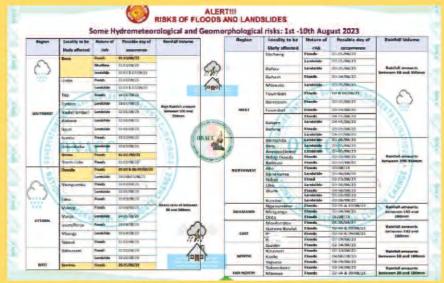
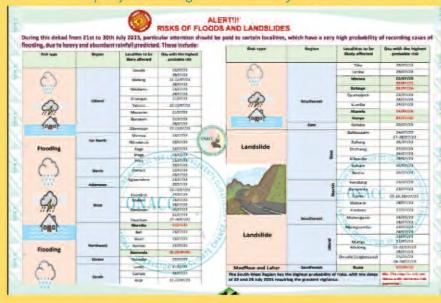
Example of two warning bulletins issued by the ONACC

The project also experimented with the dissemination of warning bulletins issued by the ONACC. These bulletins provide information on the risk of flooding and landslides at city level, with precise dates of high vigilance, and cover periods of 10 days. The City of Limbé's risk management service distributed them on the project's participatory WhatsApp monitoring system, which brings together the heads of the 10 districts of the City of Limbé. Below are the alert bulletins for July 21-30, 2023 and August 1-10, 2023. The City of Limbe actually experienced intense rainfall from July 18 to August 30, 2023, with major flooding and five landslides, two of which were fatal.

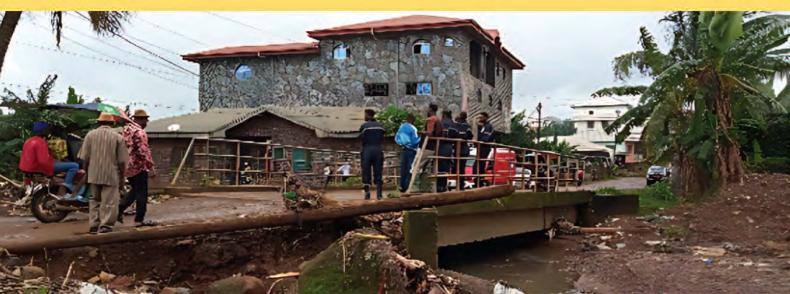
Identification of the observation point at bridge N°4
